Manhole Inspection Summary

Manhole # S31II_021MH

Insp Date: **4/11/07 12:05 PM**

Location Address: **1341 MOSHER ST**

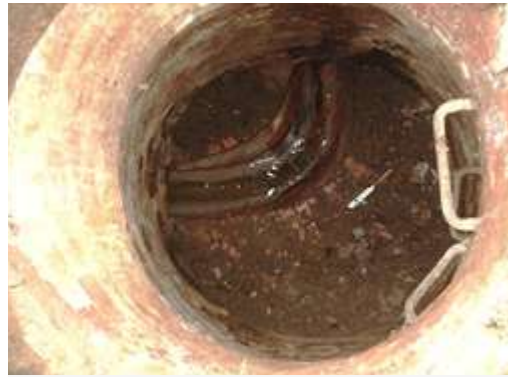
Top View

Barrel infiltration. Bench debris.

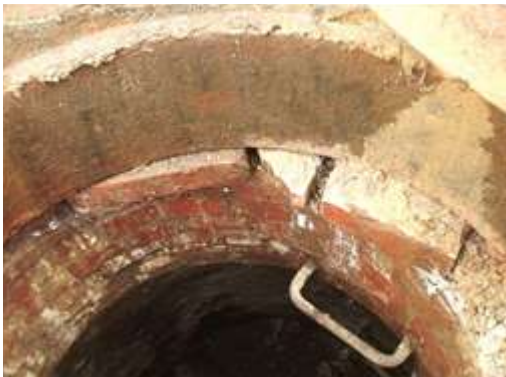
Defect

Frame leaks. Frame offset. Adjustment deterioration, loose brick and infiltration. Barrel infiltration - other side.

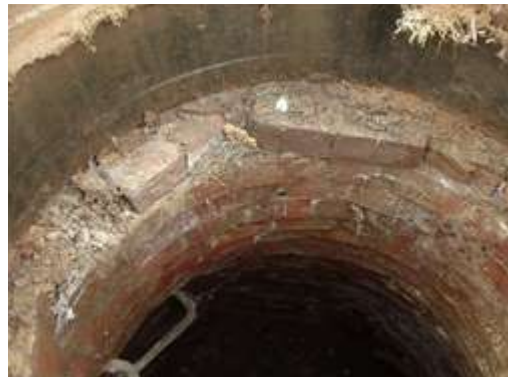
Defect

Frame offset. Adjustment deterioration, loose brick and infiltration.

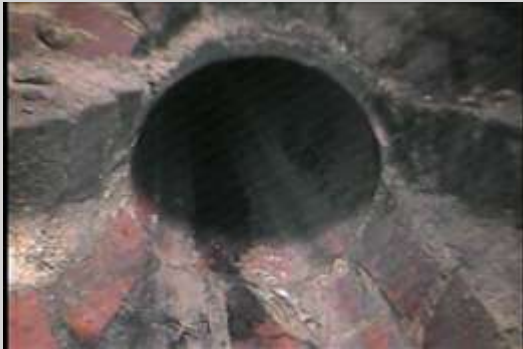
8 in. Circular Gravity Sewer Pipe Out @ 12 O'Clock

Invert Depth: **8.15** (ft.) Flow Characteristics: **Slow**

Infiltration: **None** Pipe Seal Cond: **Unknown**

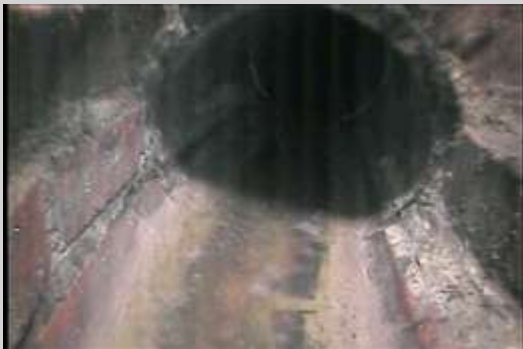
8 in. Circular Gravity Sewer Pipe In @ 9 O'Clock

Invert Depth: **7.98** (ft.) Flow Characteristics: **Slow**

Infiltration: **None** Pipe Seal Cond: **Unknown**
